# Town of Milton SIDEWALK AUDIT '25

2025 **AARP** Community Challenge

The Milton Sidewalk Audit was conducted in the Milton Village, the portion of town near the schools and restaurants along NH125. The goal of this audit is to improve walkability in the Milton Village for all residents, especially people age 50 and older.

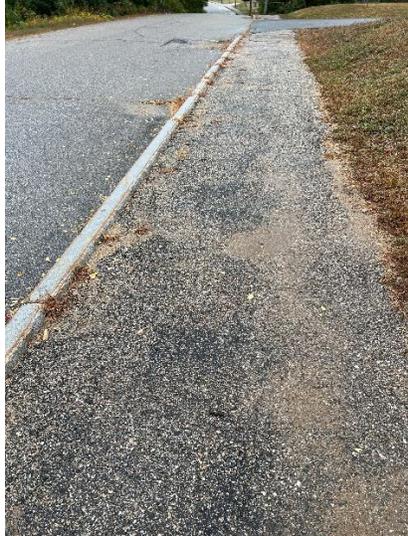
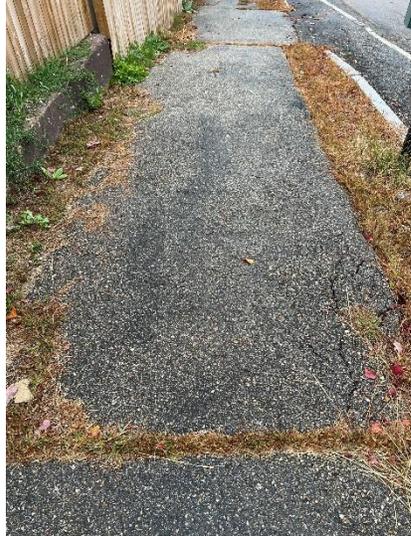
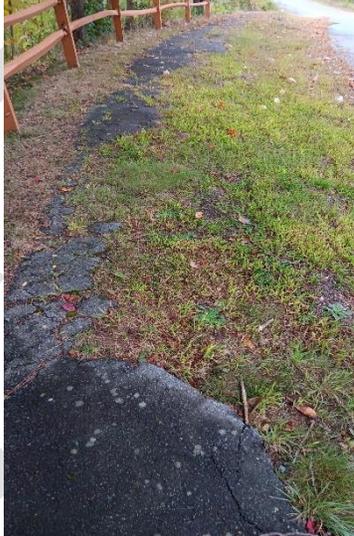
The severity of an issue refers to the degree to which it impacts someone’s ability to use the sidewalk. A small obstruction of long grass or just a few cracks are less severe than areas where the sidewalk is nearly unidentifiable as a sidewalk or with large tripping hazards or obstructions. The table below shows examples of severity of sidewalk issues, and the chart shows the severity of issues found on each road.

<b>Very Low Severity</b> Minor signs of deterioration	<b>Medium Severity</b> Significant cracks	<b>Very High Severity</b> Little of the sidewalk remains

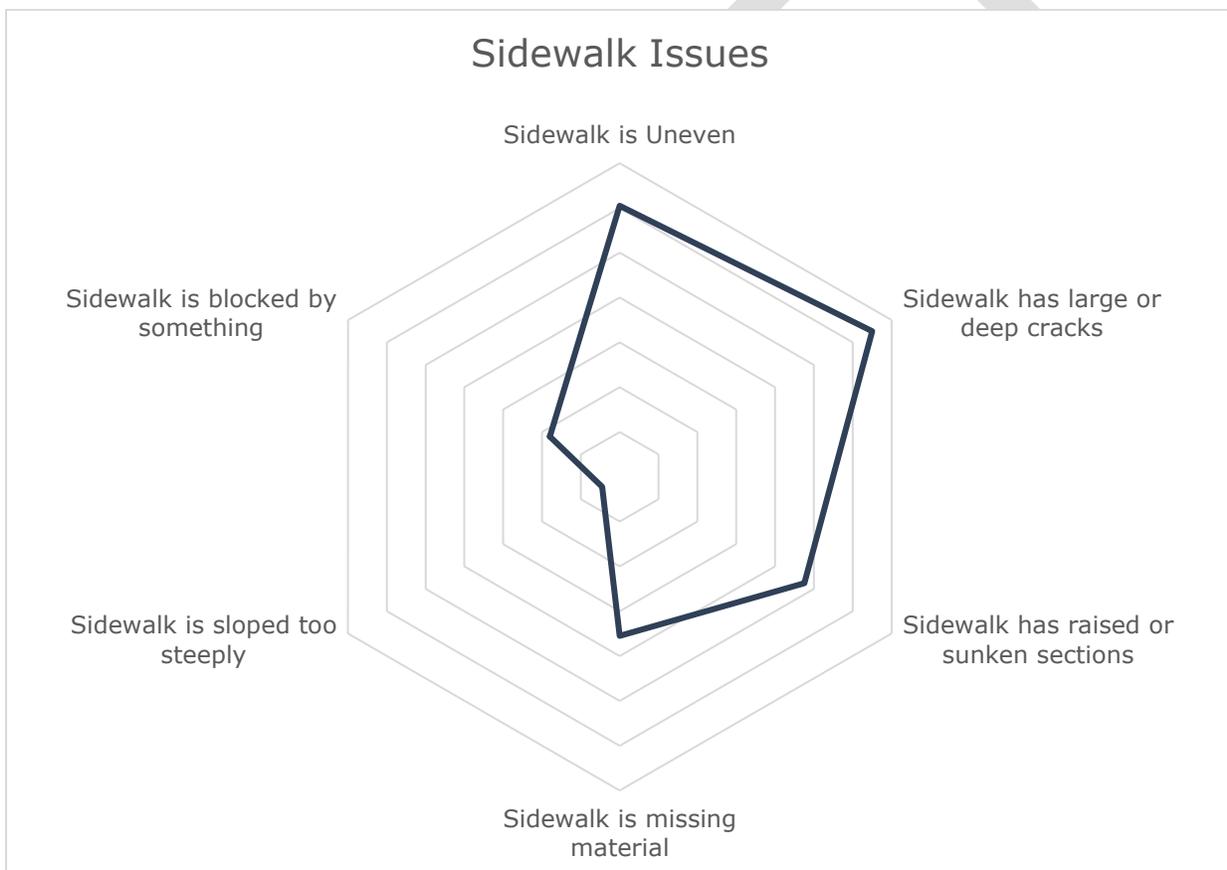
Across the study area, the biggest concerns with sidewalks were large or deep cracks, uneven surfaces, and raised or sunken areas. Some areas were missing parts of the sidewalk, and some spots were obstructed. The recommended repairs for each depend on the severity and extent of the issue.

A single type of issue could range from very low to very high severity depending on the extent of the issue. For example, one very large crack that follows the edge of a sidewalk may be a low severity crack because it does not make the whole width of the sidewalk less safe. Meanwhile, a section of sidewalk with multiple large cracks across the width of the sidewalk would be a higher severity issue. Lower severity cracking might be repaired by sealing the cracks, while higher severity cracking might require repaving.

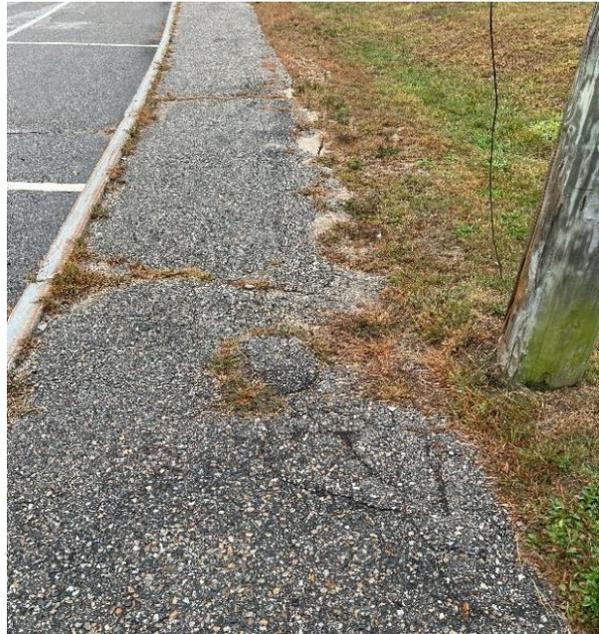
## **Large or Deep Cracks**

Large or deep cracks can be a tripping hazard and can be especially difficult for people using mobility devices such as wheelchairs or walkers. Cracks can also have grass grow out of them and allow water infiltration and increase the rate of deterioration.

Cracks that are spread out but not particularly deep or long could be crack sealed, similar to a road paving treatment for minor and spread out cracking. The rest of the sidewalk's life can be extended by sealing these cracks and preventing them from getting worse. However, if the severity remains high for multiple segments of sidewalk, a repave may be a better option aesthetically and financially over time.

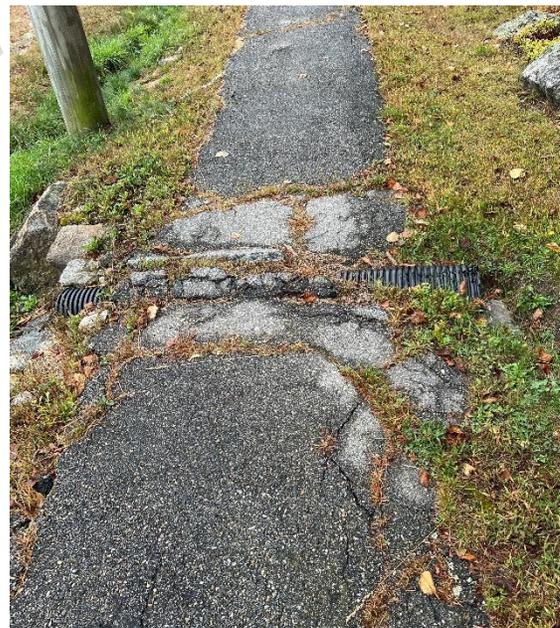
## **Uneven Surface**

A generally uneven sidewalk can be a tripping hazard and make the sidewalk more difficult to travel in a wheelchair or with a stroller. The causes of uneven sidewalks can vary and are generally more expensive to resolve. An uneven sidewalk could be collapsing due to issues in the ground below the pavement or bulging due to a tree root or drainage pipe. Regardless of the causes, an uneven sidewalk may require removing the existing sidewalk to resolve the underlying issue.

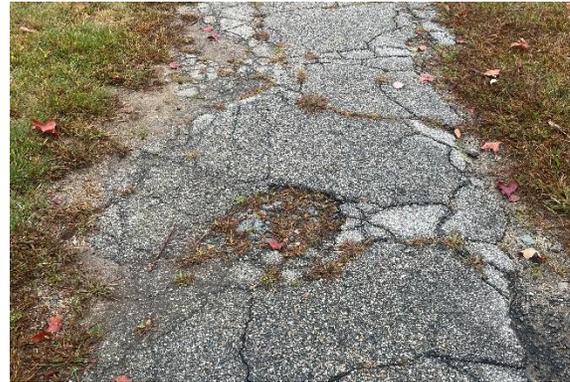
### **Raised or Sunken Sections**

Raised or sunken sections of sidewalk are often tripping hazards, and sunken sections can allow pooling water which can increase deterioration. Raised sections are typically due to tree roots pushing the sidewalk up from underneath. Either will be an issue that will only exacerbate over time, especially in a town with as much water as Milton.

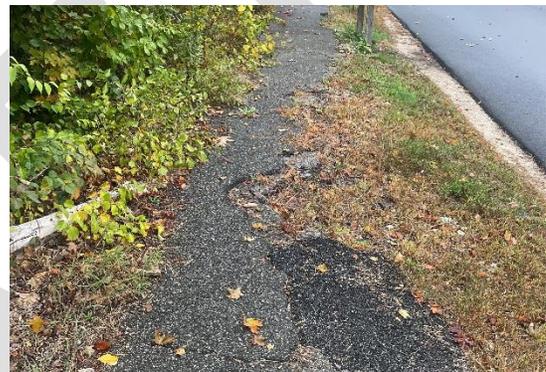
### **Missing Material**

Sections with missing material (asphalt) are a tripping hazard and the sidewalk is at risk of being lost entirely. This is indicative of an area that has received a "washout" from a rain runoff or the sidewalk has cracked so frequently that pieces are starting to come out of the alligator cracks.

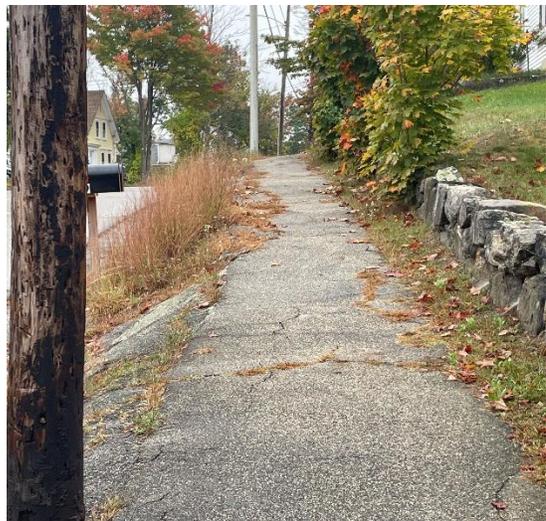
### **Too Steep**

A steep sidewalk is an inconvenience to most pedestrians, but can be hazardous or difficult to traverse in a wheelchair or with a walker or stroller. The ADA defines a slope greater than 5% as too steep. While often there is little to be done about this, particularly on streets with steep hills, it is still worthwhile to be aware of these areas and consider wider sidewalks or increased signs to increase driver awareness of sidewalk users who may be struggling.

that is pushing the sidewalk up. The latter two causes can be fixed.

Sidewalks that are too steep may be steep due to topographic issues such as a hill, as a result of designs that make them too steep, or as a result of a root

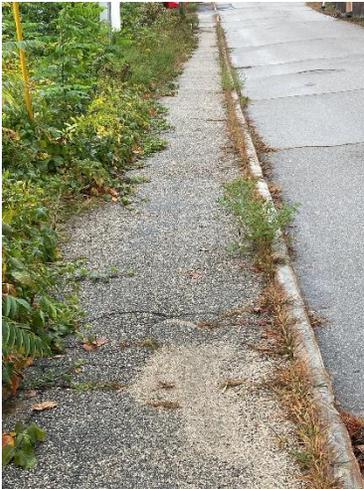
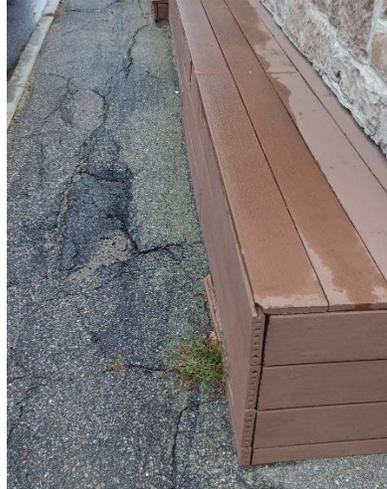
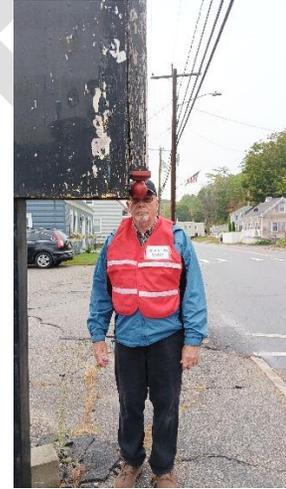
There are two major types of obstacles a person can encounter, temporary and permanent. Temporary obstacles include such as overgrown vegetation, trash cans, or parked cars. While more permanent obstacles include a telephone pole in the middle of the sidewalk, mailboxes, hydrants, and drains. Each have their own unique respective solutions to each obstruction.

The obstructions in Milton range from overgrown plants to utility poles and the sign at Brian's Flooring.

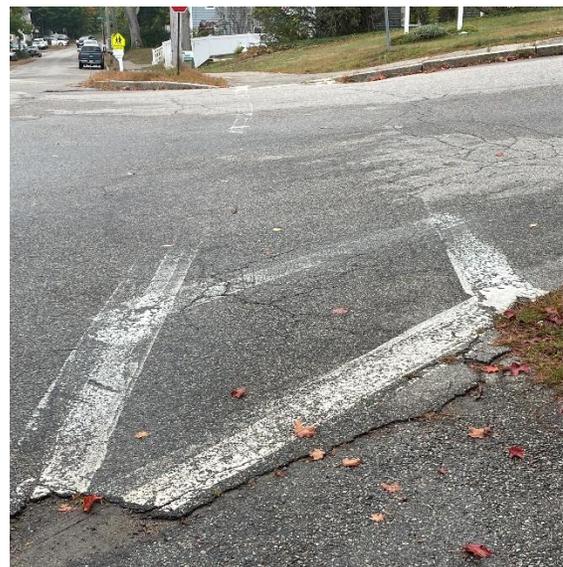
Street crossing concerns were primarily related to striping or signage for the street that is being crossed. The severity of these concerns is based on what street is being crossed.

The minimum severity for a crosswalk that needs to be painted is "Medium" as clear crosswalk markings are needed to indicate to drivers to yield for pedestrians. All crossing issues that are related to attempting to cross NH 125 are automatically "Very High" severity due to the traffic volume and speed on NH 125. An ideal improvement to these crossings would be reflective paint and button activated flashing beacon lights.

All re-striping for crosswalks are relatively inexpensive and can be worked into annual paving programs.

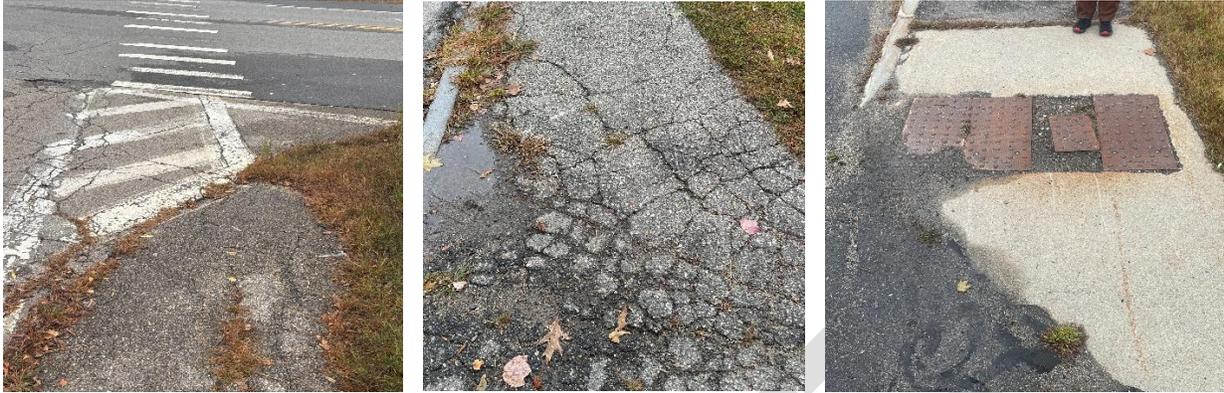
Other common street crossing issues were curb ramps that have been damaged over time. A few curb ramps were identified that were in need of repairs.

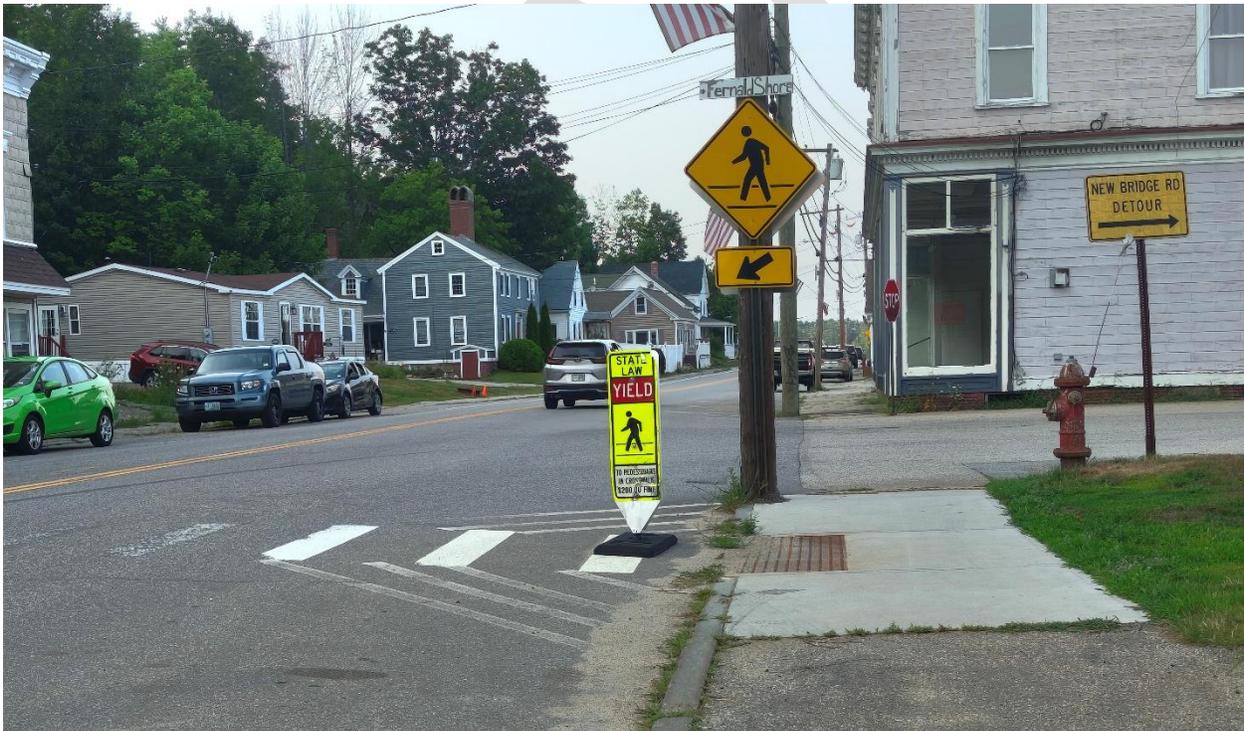
The final concern that was flagged for street crossings in Milton were the overall safety of the NH125 crossings. NH125 is a state route with an average daily traffic volume of 5,700 cars per day. The high volume and speed of traffic make crossing NH125 particularly challenging. Better signage or pedestrian beacons could improve this.

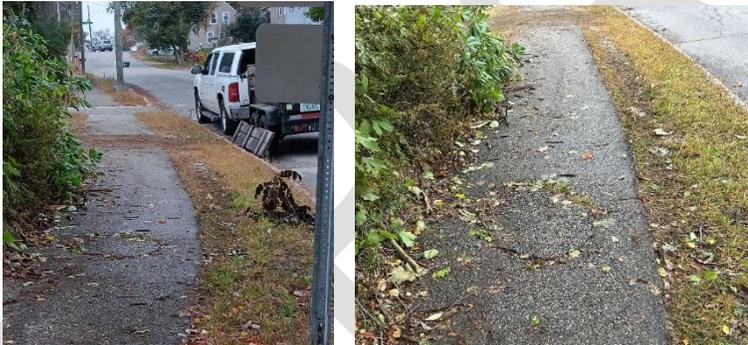
- minor and easily remedied obstructions,

1. Vegetation obstructions should be cut back. This can be repeated annually.
2. The sections of Dawson St from Steeple St to NH125 should be prioritized for paving.
3. The sections from Brown Ave to Steeple may be candidates for crack sealing and patching in the short term and considered for paving in 10 years.

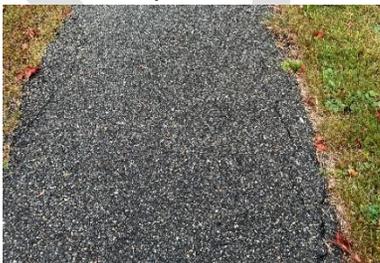
- early and minor edge cracking that should be monitored but is not in urgent need of repair

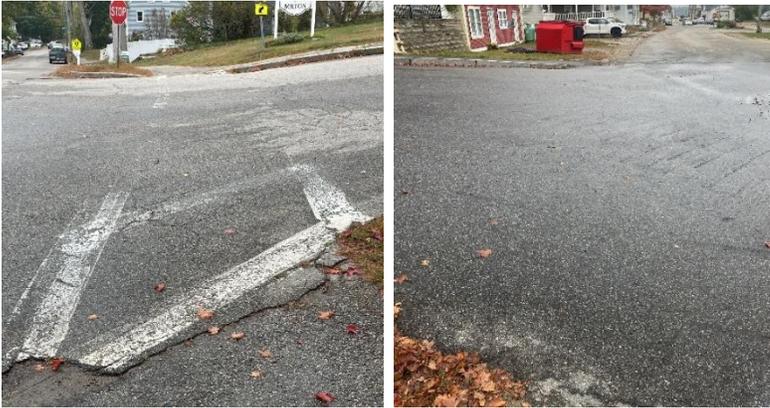
- Crosswalks that need a fresh coat of paint

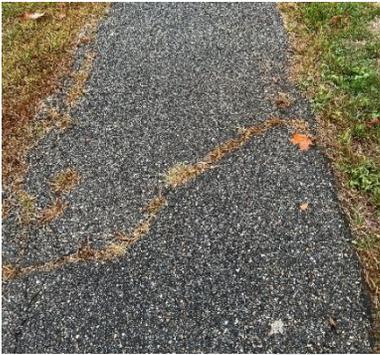
- Slightly more prominent cracking that could be resolved with some crack sealing

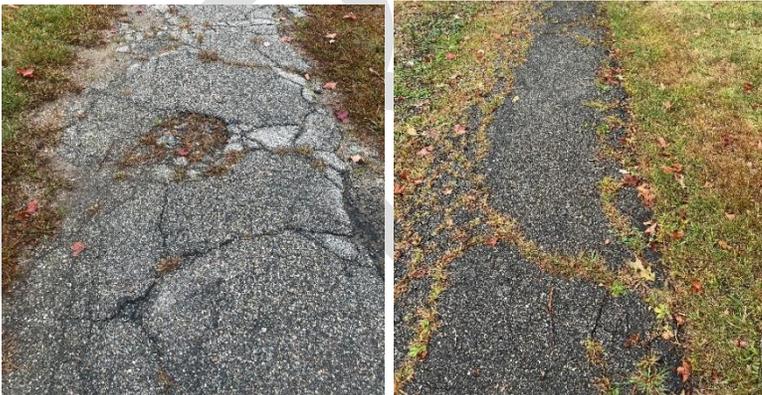
- Increasingly severe cracks that will need to be repaved in the near future

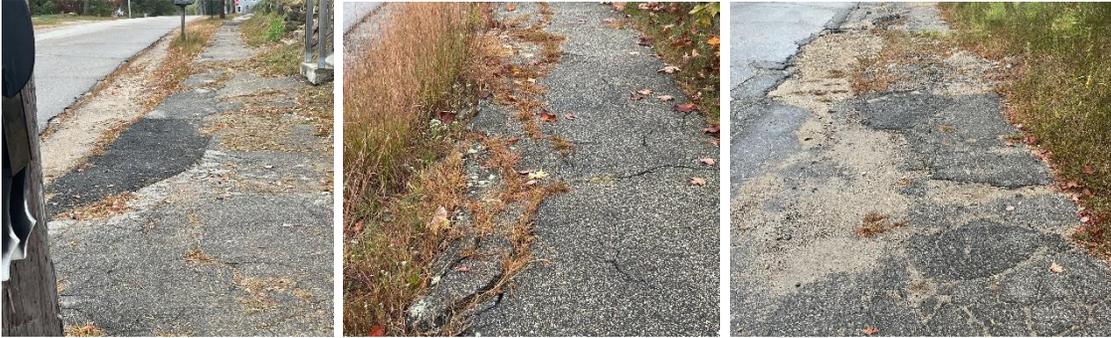
- Edge cracking that is starting to erode one side of the sidewalk

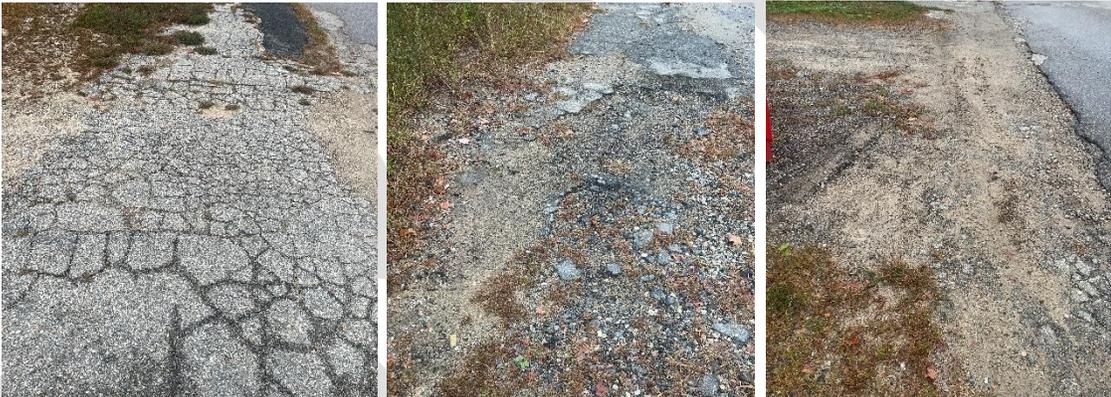
- And alligator cracking that will need to be completely repaved

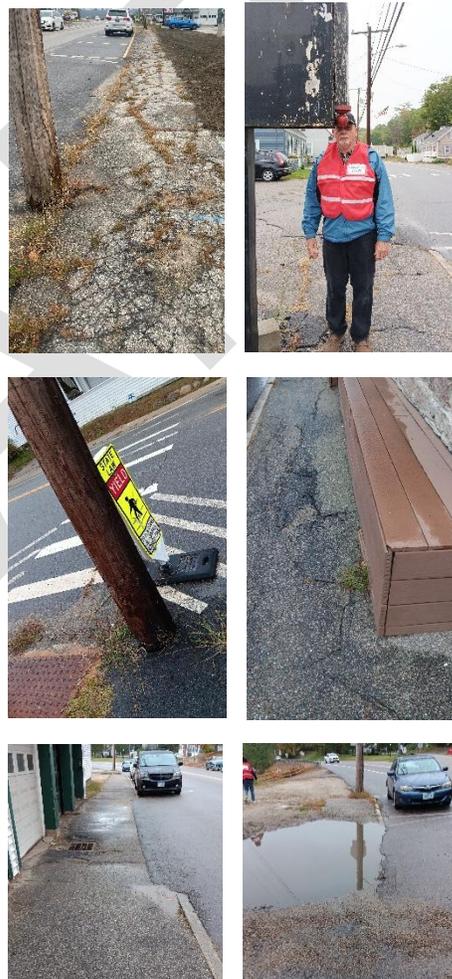
NH125 had 48 issues logged (44 sidewalk, 4 street crossing). The recommended repairs on NH125 are more expensive than some of the local roads. The sidewalks are deteriorating and obstructed by signs and benches on the northbound side of the road. On the southbound side of the road, the sidewalks near the Cumberland Farms and Dunkin' are deteriorating, while the sidewalks near the Pizza Nook could be patched and last another 10 years.

There were a few issues reported that were caused by private driveways that resulted in uneven surfaces for pedestrians, but these are not up to the town to repair.

1. Install button activated flashing beacons at Mill St and Garage Way crossings.
2. Repave northbound sidewalks in short term (1-5 years).
3. Repave southbound sidewalks in mid-term (3-8 years).
4. Request that NHDOT reduce the speed limit to 25 mph from Dawson St to Depot Pond Rd.

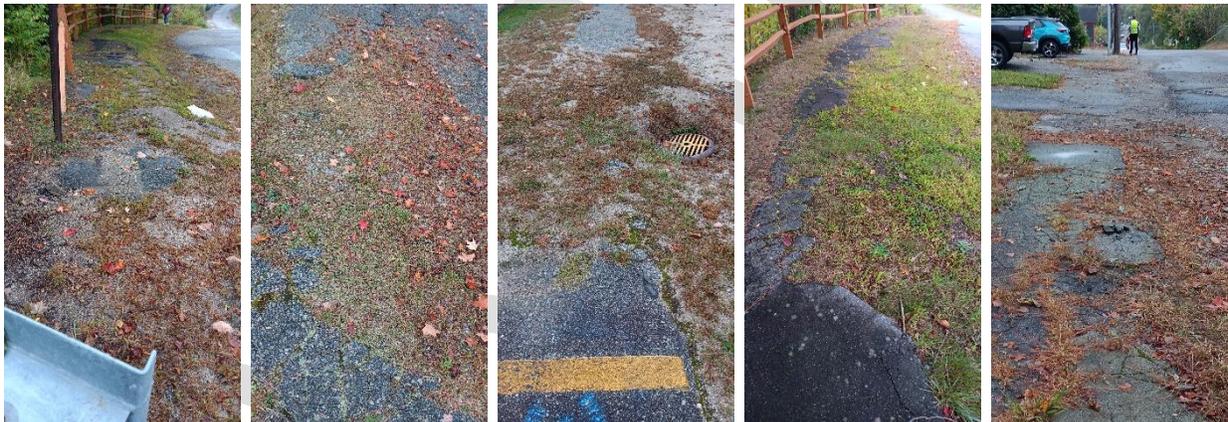
Charles St had 22 issues logged (all sidewalk). Charles St's sidewalks are in a state of disrepair and in some locations are barely identifiable as sidewalks. Additionally, the sidewalks are often used as on-street parking, with at least three cars parked on the sidewalk during the audit. Charles St's sidewalks should be repaved entirely and more clearly separated from the street.

1. Charles St should be prioritized for sidewalk reconstruction.
2. Consider connecting to sidewalks along NH125 through a multi-use path in the park rather than extending sidewalks along NH125.

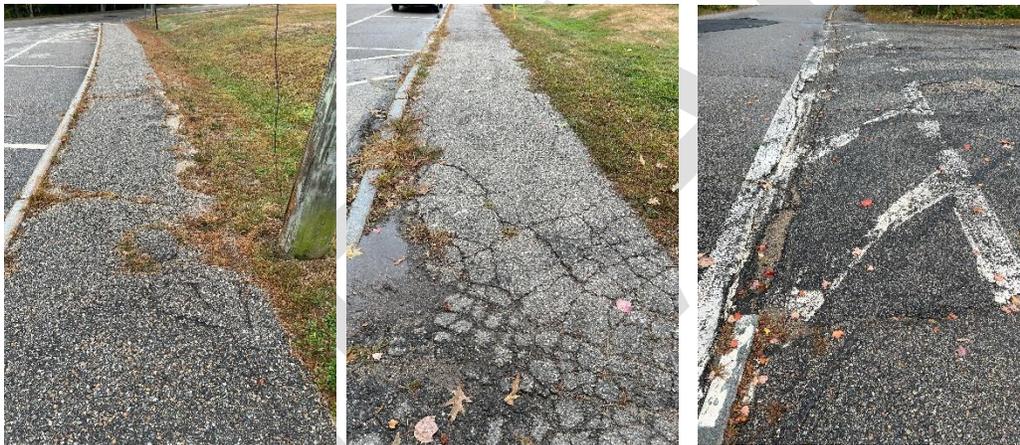
School St had 21 issues (16 sidewalk, 5 street crossing). School St is generally in good shape. Most of the reported issues are early signs of cracking that could be crack sealed now and prolong the life of the sidewalk for 10-15 years. There are a couple of spots with some alligator cracking that should be considered for a small patch. The final concern on School St was that the crosswalks are fading and should be restriped within the next few years.

1. Restripe crosswalks within 1-5 years.
2. Crack seal or patch some of the more severe cracks (1-5 years).
3. Repave next time the road is paved.

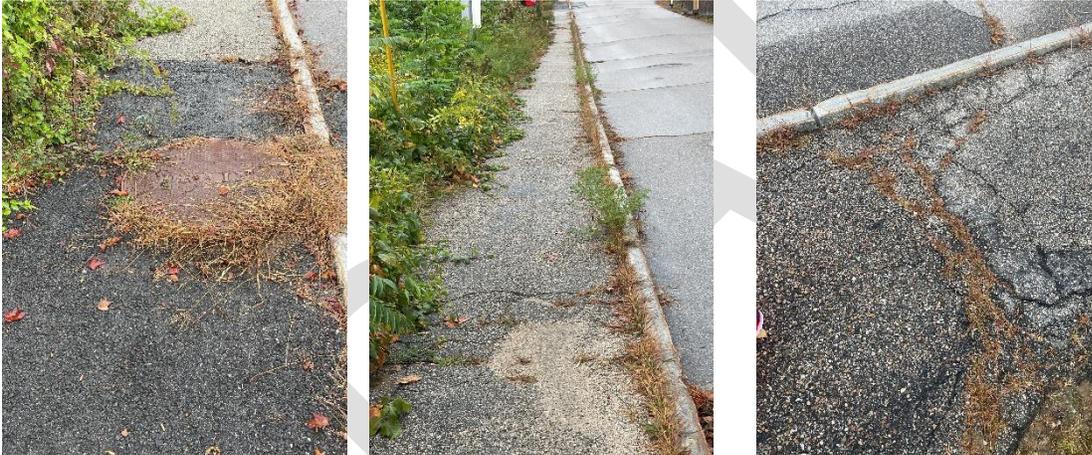
Steeple St had 18 issues (16 sidewalk, 2 street crossing). The section from Dawson to School St has more prominent cracking, and the section from School St to Silver St features more obstructions including a manhole cover that is raised above the surface of the sidewalk.

1. Cut back vegetation.
2. Adjust manhole cover to cause less of a tripping hazard.
3. Repave in 8-10 years.

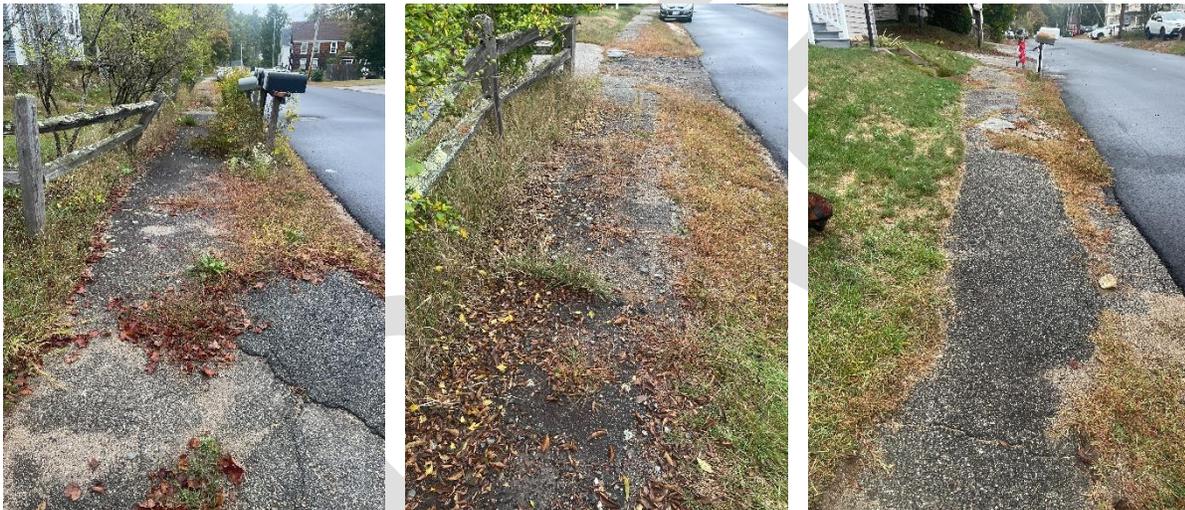
Depot Pond Rd had 16 issues logged (all sidewalk). These issues are more severe degradation to the sidewalks and replacement is the most feasible option. The sidewalk also ends before the end of the street.

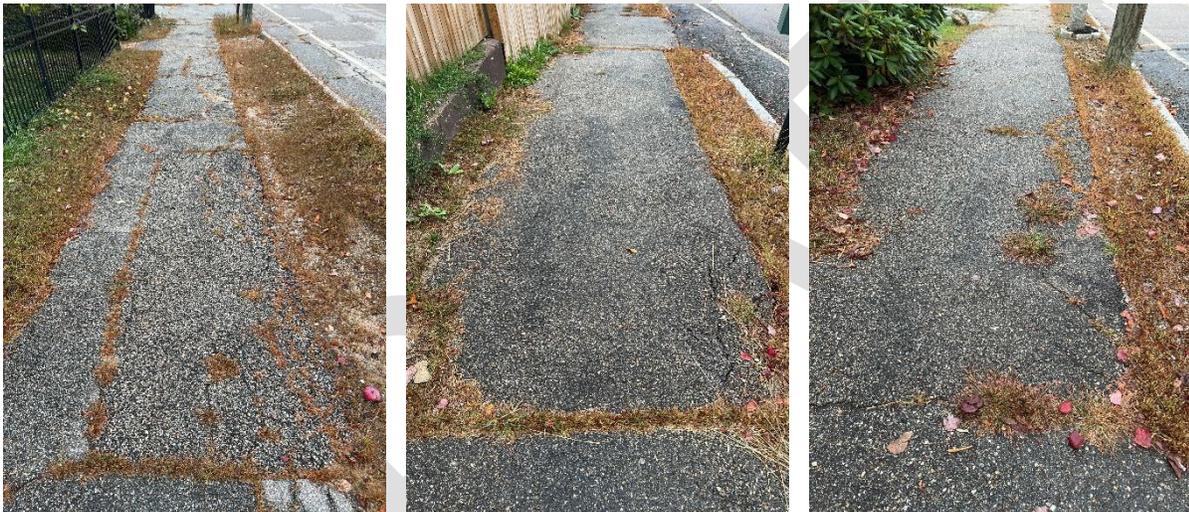
Elm St had 11 issues (10 sidewalk, 1 street crossing). Elm St's issues were more extensive. Individual issues could be fixed with patches, but they are extensive enough that it may be more cost effective to pave in 6-10 years.

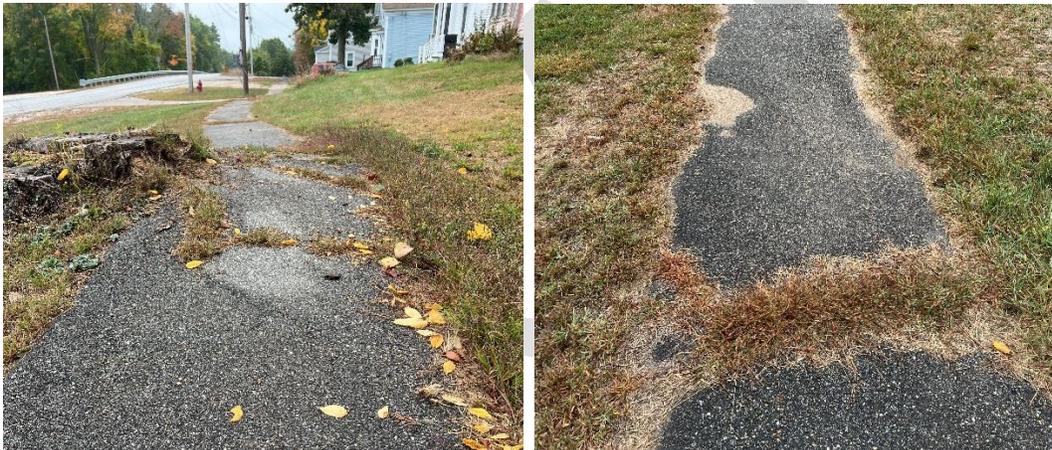
Brown Rd had 4 issues (3 sidewalk, 1 street crossing). These were higher severity issues that will likely require repaving sections of the sidewalks. One spot has the roots of a large tree that has been cut down under it, while two others have large 1" or wider cracks that have grass growing out of them. The street crossing issue is for the crossing of NH125 at the old town office. This intersection would benefit from a flashing beacon and crosswalk.

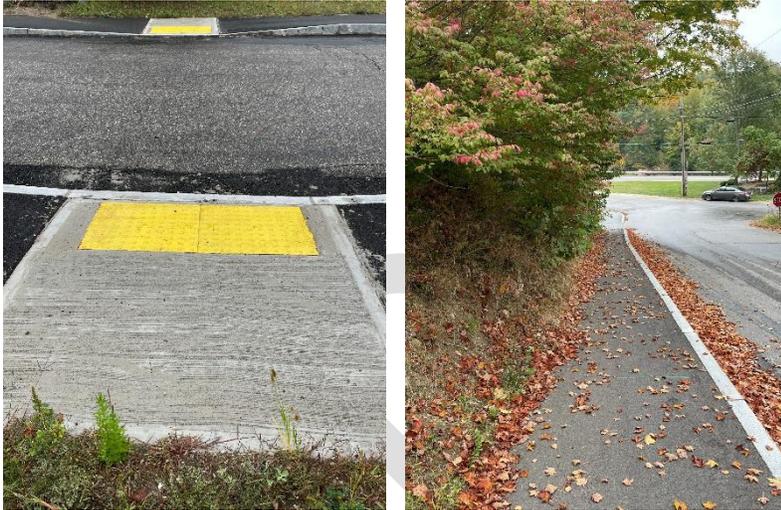
Silver St had 5 issues (2 sidewalk, 3 street crossing). Silver St's sidewalks were recently reconstructed, so all 5 issues are regular maintenance issues. The two sidewalk issues were branches that hang into the sidewalk and block it. The three street crossing issues are all crosswalks that need to be painted.

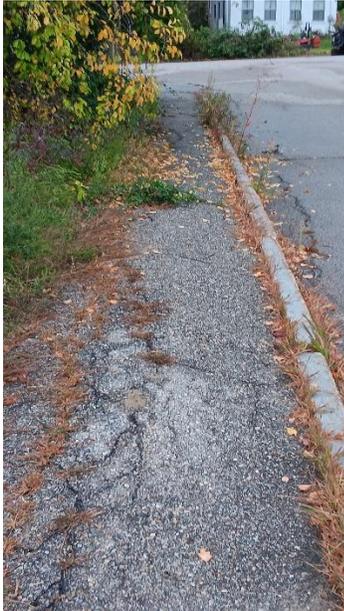
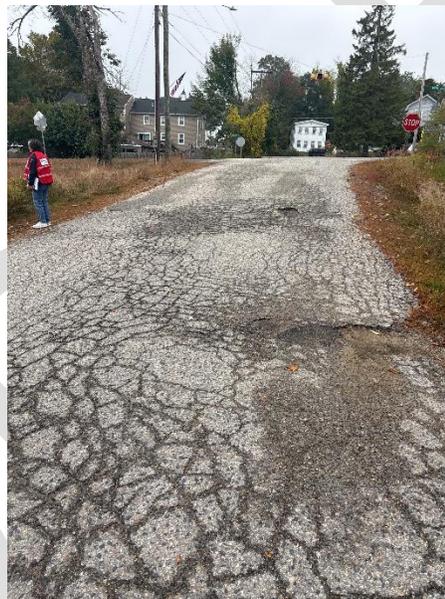
Mill St had 3 issues (2 sidewalk, 1 street crossing). Mill St only has sidewalks on the Dawson St to NH125 section, and it is in need of repairs. An extension of sidewalks down to Charles St and a flashing beacon at the NH125 crossing would connect Charles St to the rest of the sidewalks in town.

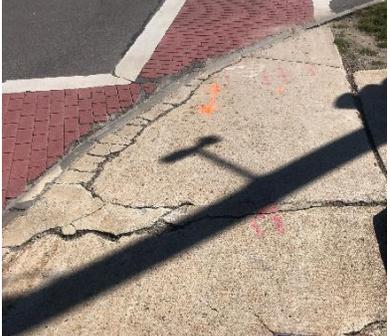
Surface defects	Description	Example (photo)
Large cracks	Cracks over one inch wide

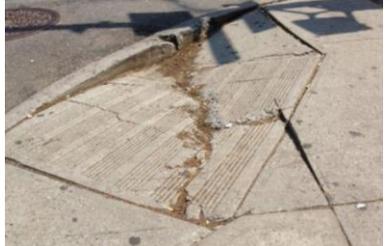
Raised/sunken sections	Sections of sidewalk dip and raise inaccessibly

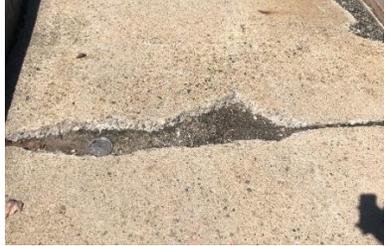
Missing material	Over one inch wide of material missing from sidewalk

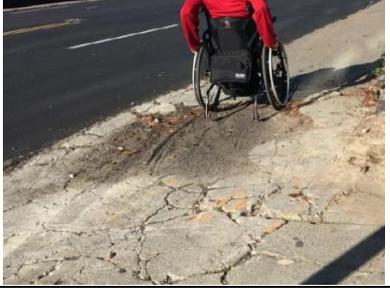
Uneven sidewalk/Sloped too steeply	Slope or condition is dangerous between driveways or paths
